**ARBORICULTURAL ASSESSMENT
&
IMPACT REPORT**

**RESIDENTIAL DEVELOPEMNT
STEPASIDE PARK
STEPASIDE
CO. DUBLIN**

Project No.	Project name	Date	Revision
TSTE003	STEPASIDE SHD	27/06/22	A

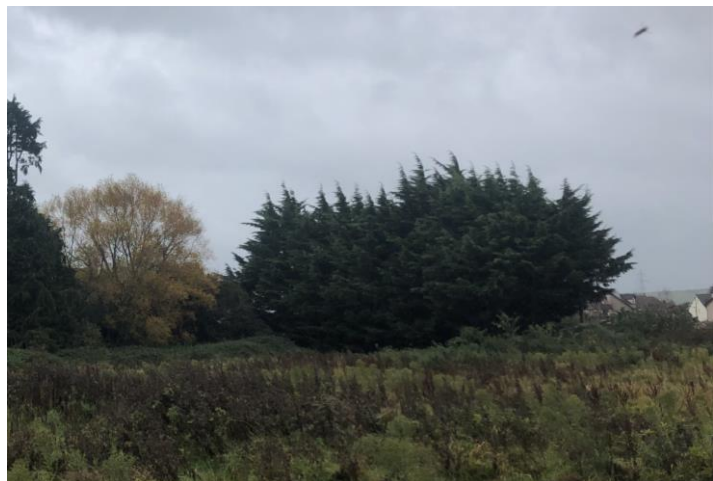
The tree population within the site is composed of a double line of Monterey cypress (*Cupressus macrocarpa*) (image 2). These trees are relatively well developed but serve no real purpose in the context of the site. They run on a north / south axis rather than forming a boundary screen or other purposeful planting.

Image 2. Monterey cypress toward the northern section of the site

Tag number	Species	Age Class	Vigour	Comments	Preliminary Recommendations	Category	Long-term potential (years)	Dbh mm	Height m	Spread m N, E, S, W	Clear stem m
1485	Monterey cypress Cupressus macrocarpa	Mature	Good	A double line of trees / overgrown hedge at 2m spacings. Canopies restricted due to competition within group.	No action necessary	B2	20-30	390 av	10	4,4,4,4	0

The proposed development will necessitate the removal of the Monterey cypress #1485 hedge which falls within the road alignment.
