Title: **QUALITY AUDIT  
INCLUDING**

**Road Safety Audit, Access Audit, Cycle Audit and Walking  
Audit.**

**Stepaside Park Phase 3**

Report reference: **1507R01**

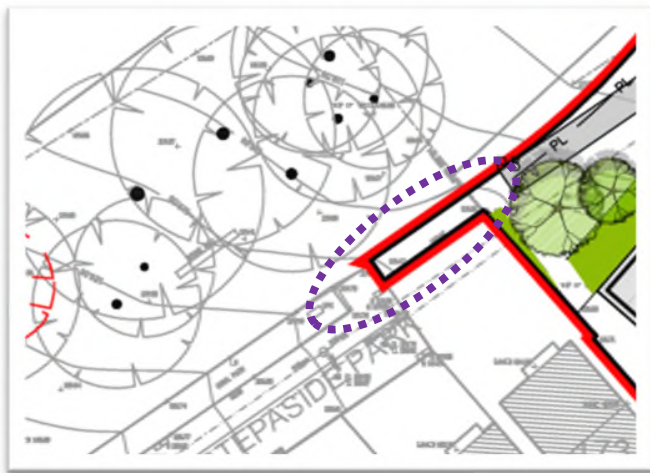
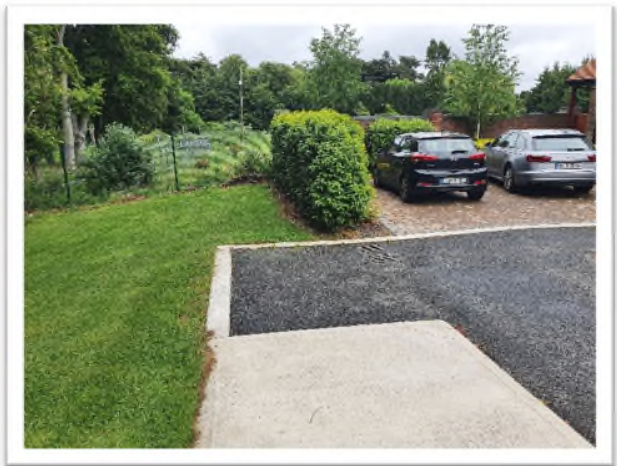
The proposed footpath link at the north eastern corner will have a discontinuity. This could lead to trips and falls.

It is recommended that the footpath be made continuous and that its effective width be made sufficiently wide to cater for the future demand. This may require the cutting back of the vegetation. The footpath link should also ensure that pedestrians do not conflict with turning vehicles in the hammer head.

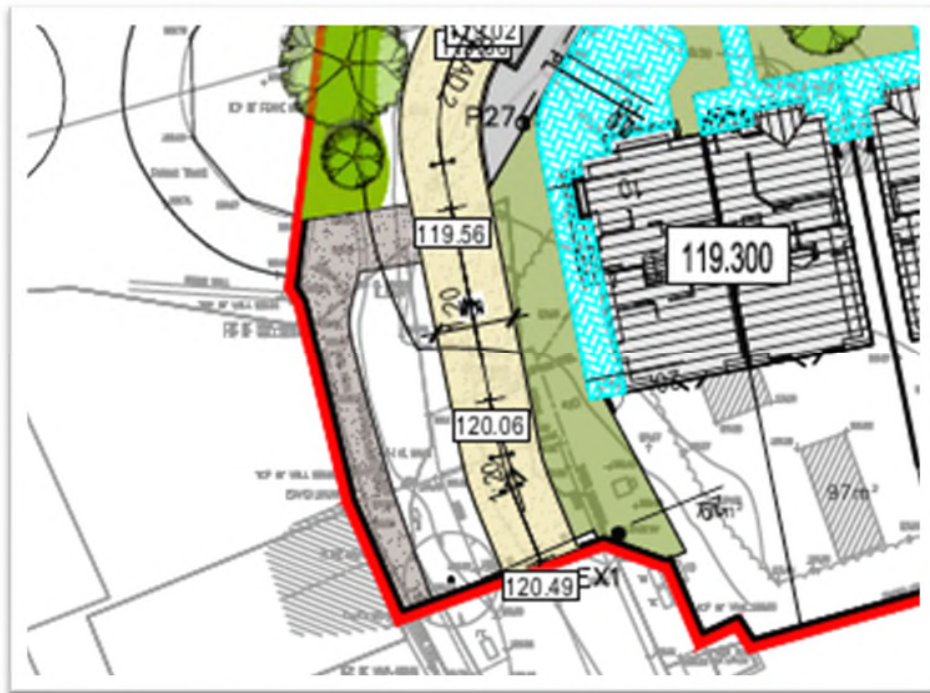
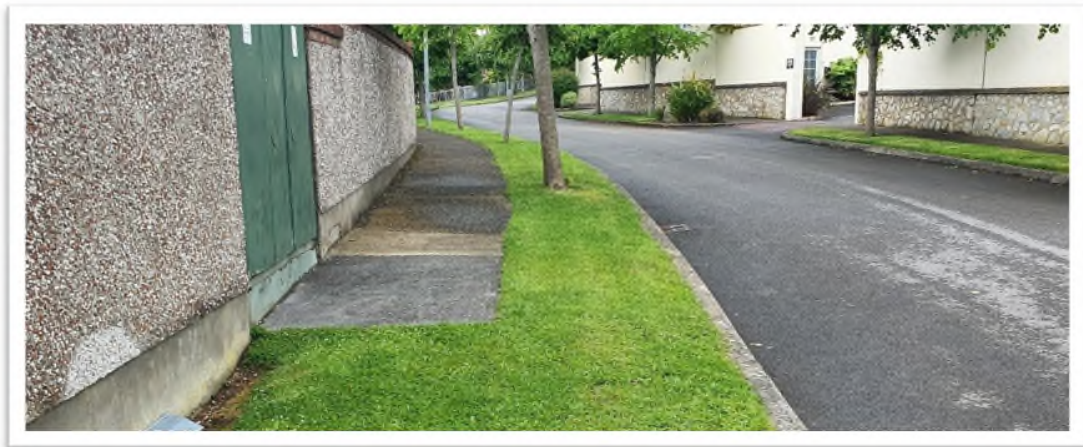
A short section of homezone is proposed at the connection to the existing road network. This will be a busy section of carriageway until the future Loop Road is constructed. The lack of segregated pedestrian areas at this point may increase the likelihood of a collision.

It is recommended that the segregated footpaths on both sides of the carriageway as per the existing cross section be maintained throughout this section.

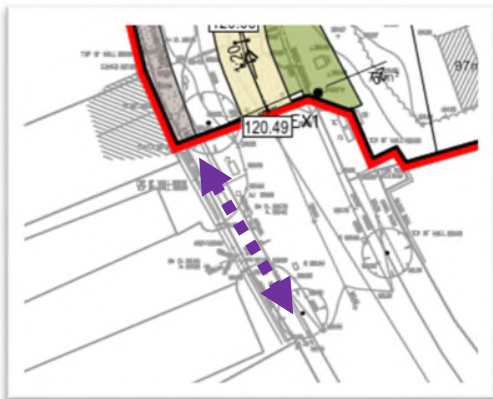
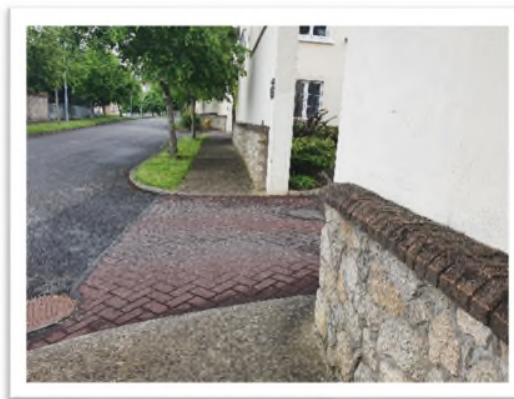
It is proposed to provide a new footpath on one side of the connection with the existing road network. The existing boundary wall of the Earls Court estate restricts visibility for drivers exiting the car park. When the road is extended the usage across this access will increase thereby increasing the risk of a collision with a pedestrian.

It is recommended that a footpath on the opposite side of the carriageway also be provided.

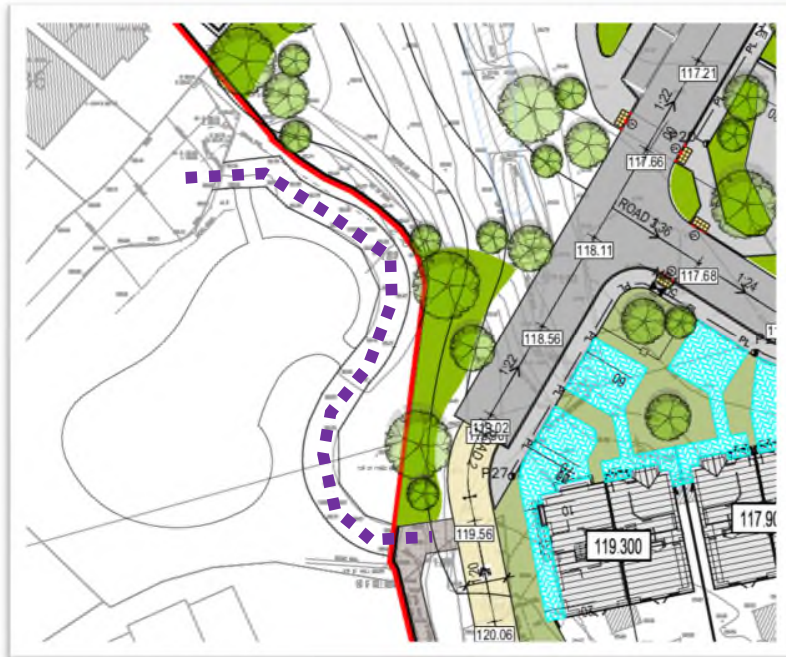
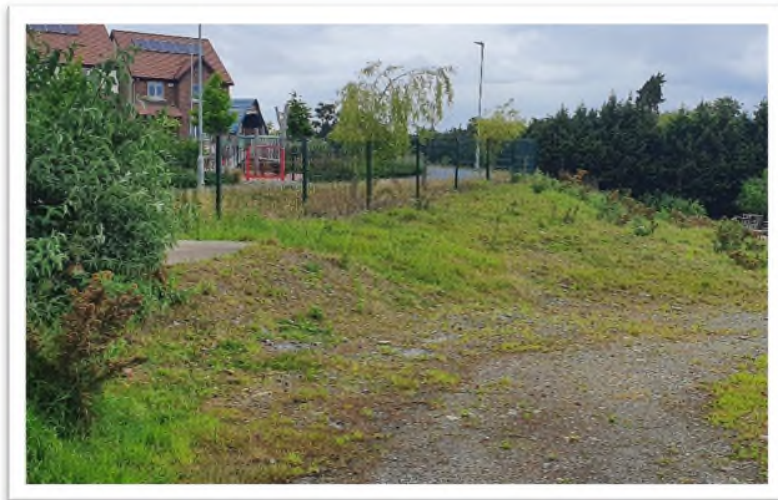
It is unclear what the gradient will be from the new access road to the playground. If the gradient is too steep it may not be accessible to the mobility impaired including those pushing buggies and those in wheelchairs.

It is recommended that a suitable gradient be provided to the playground and to the road at existing house no. 187.

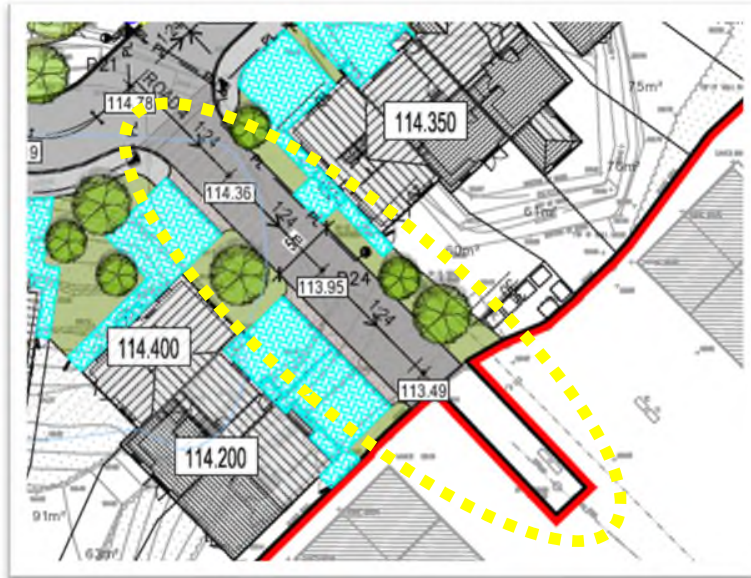
It is unclear what the proposed surface finish is to be on Road 4. The material used in the existing estate road represent a homezone and a slow moving environment.

It is recommended that the proposed surface be similar in colour and nature to the existing road it is tying into.

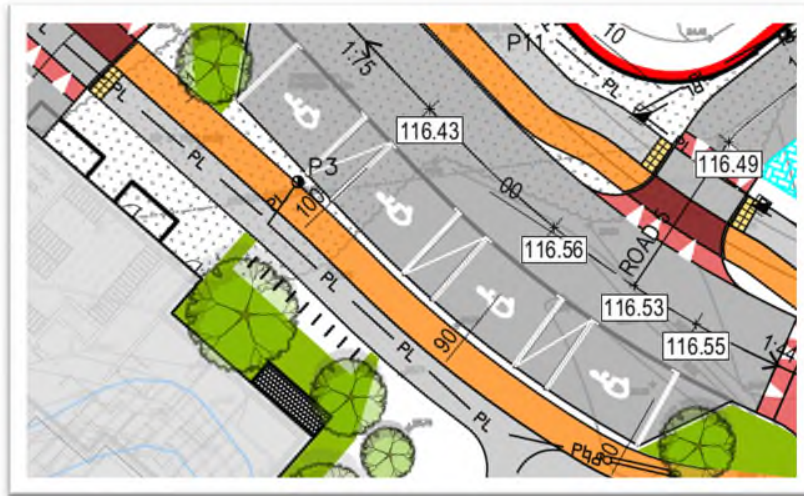
It is proposed to provide 4no. disabled parking spaces along the Loop Road adjacent to the cycle track. This may lead to conflict to those users and cyclists if they need additional time to access/egress from their vehicles

It is recommended that a wider buffer zone be provided to avoid blocking of the cycle track.

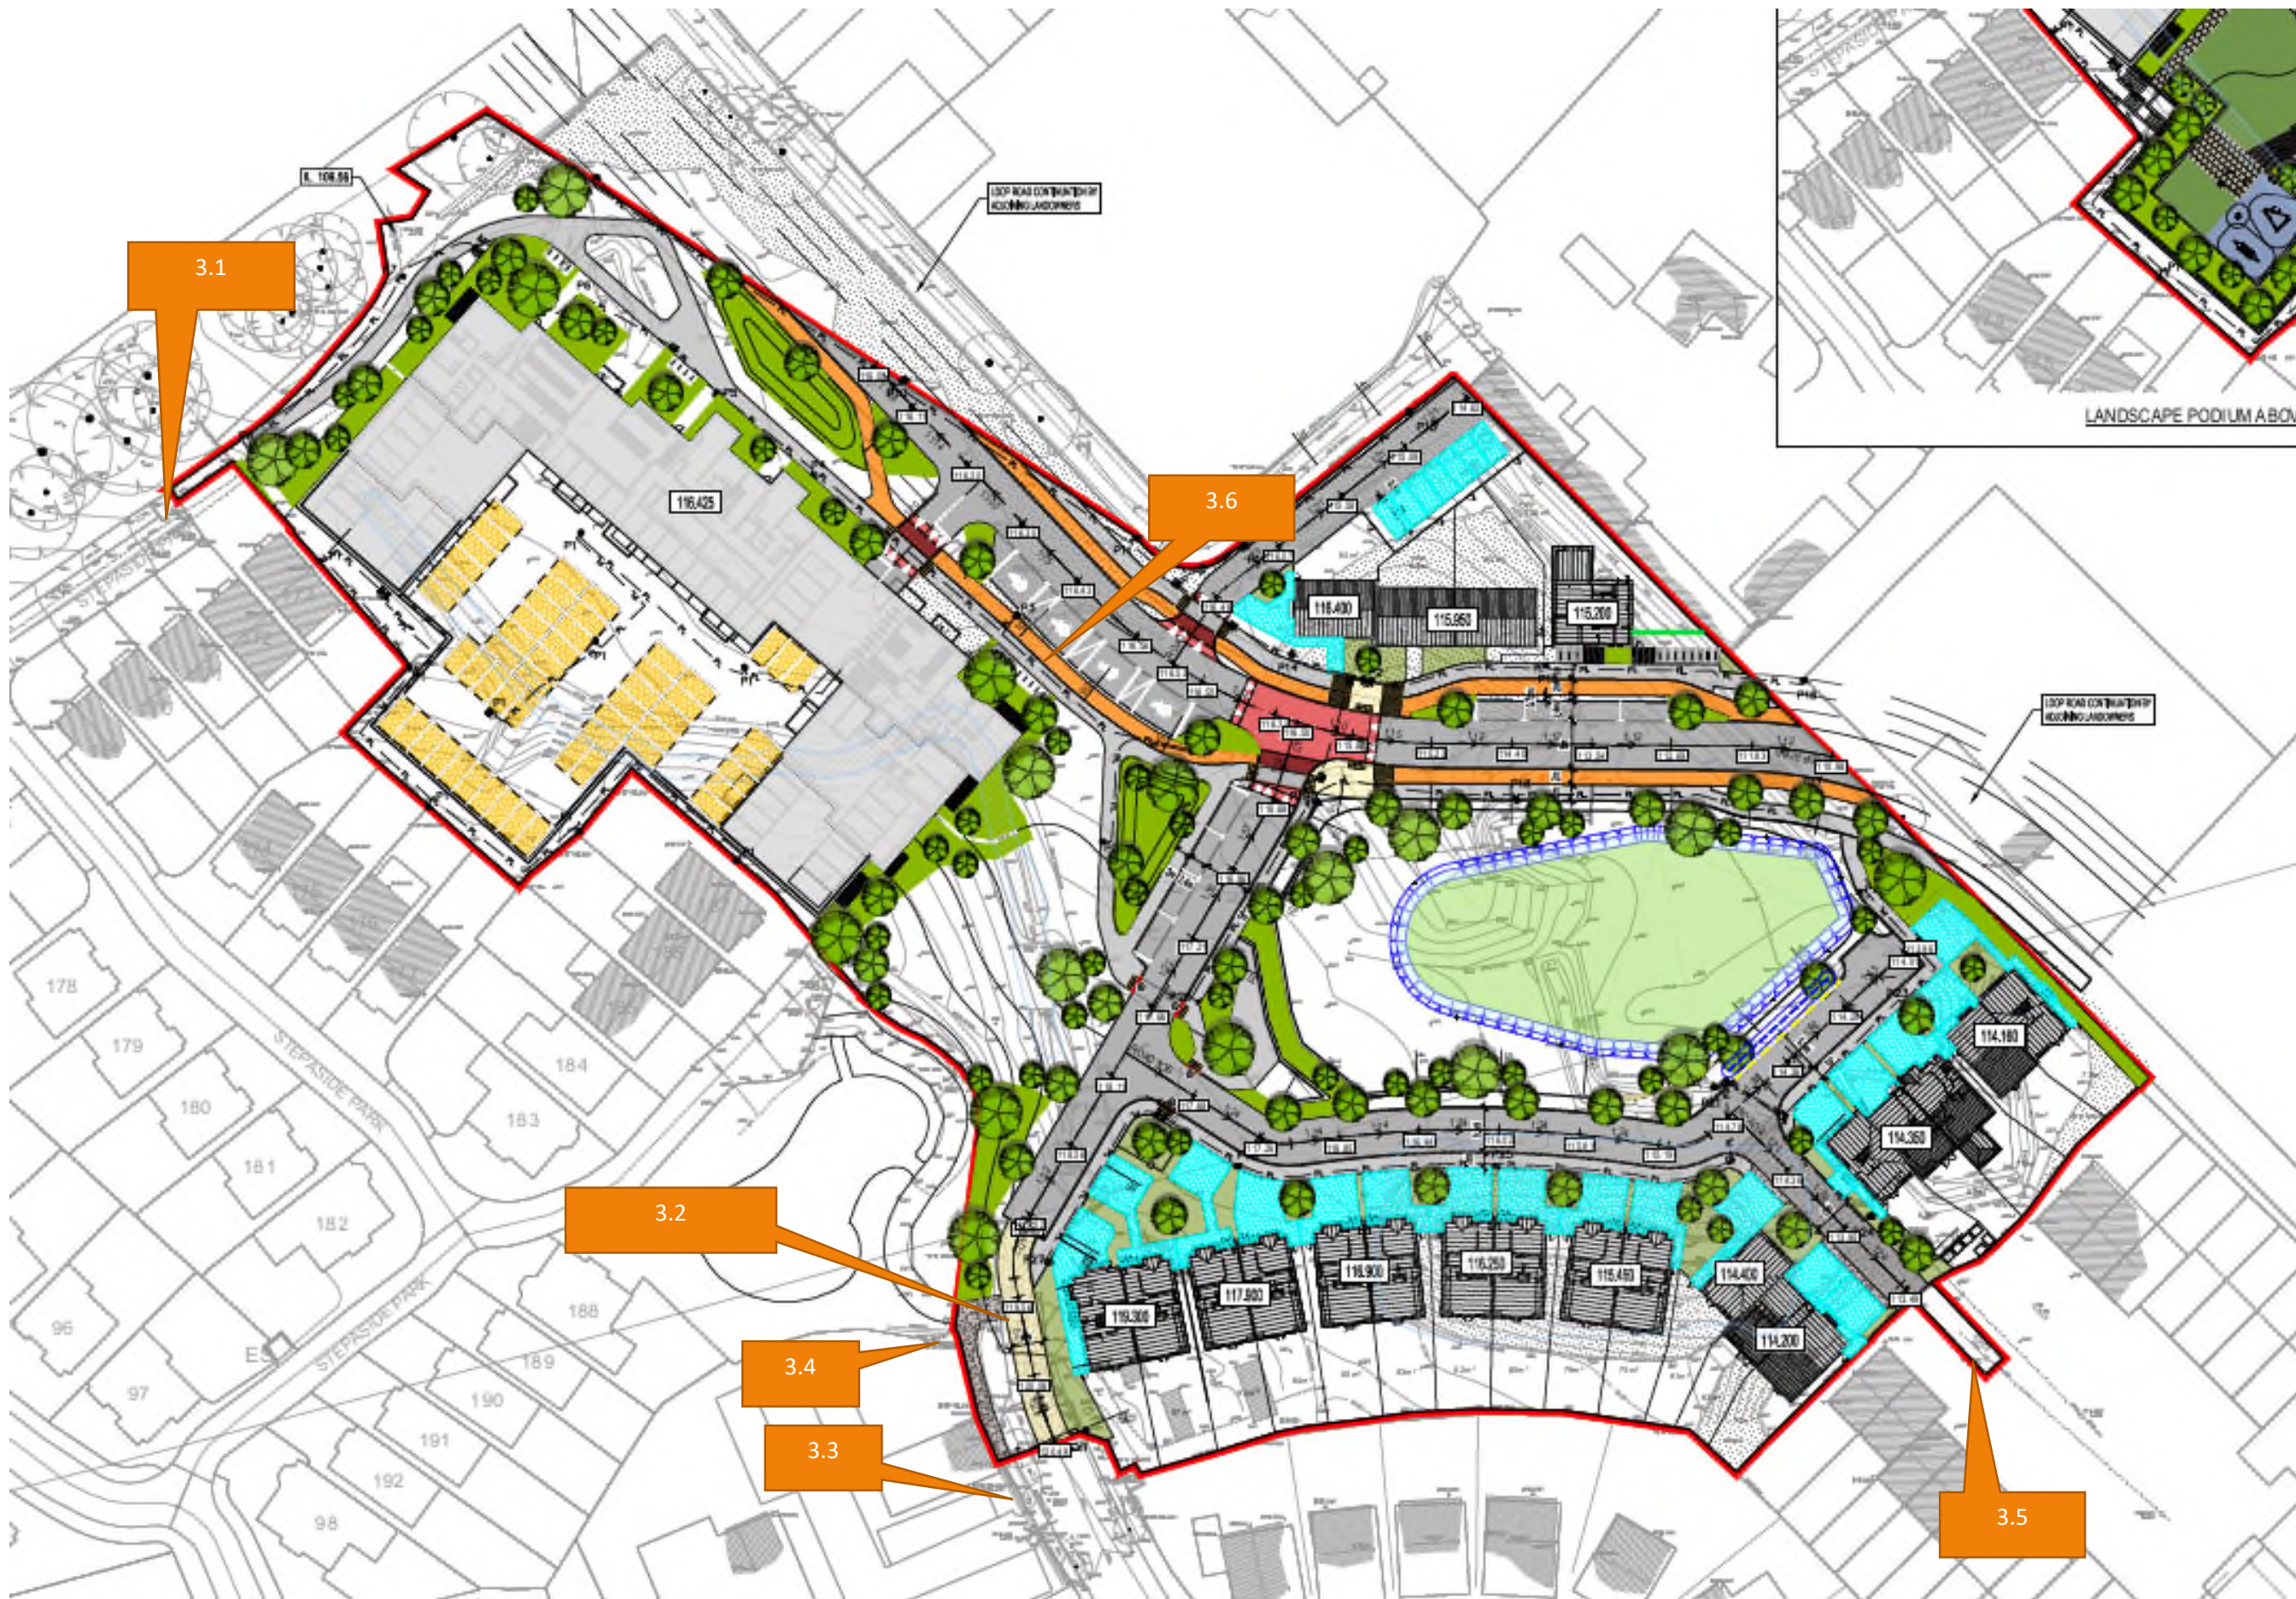
### Problem Location Plan.

A plan drawing showing the problem locations is contained in **Appendix C**.
